**Benton District Historic Resources
Survey and Inventory**

Prepared by
Diana J. Painter, PhD
Sonoma State University

Fall 2004

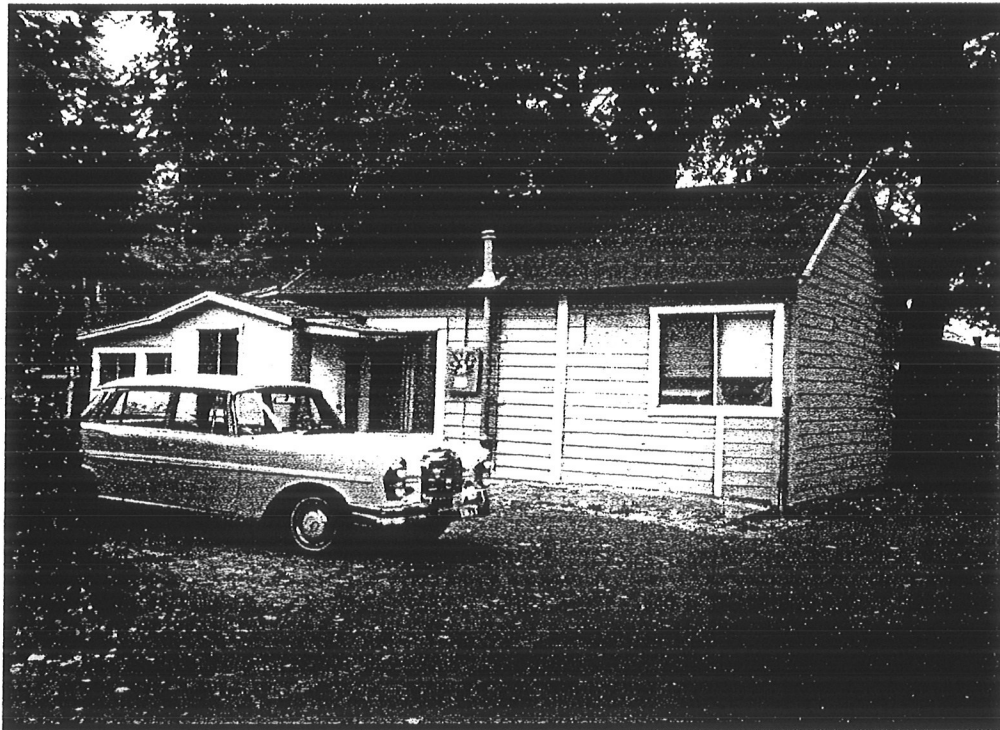
814 ½ Orchard is a one-story residence on the back of the lot on which #814 is located. The main entrance is enclosed within a gable-roofed enclosed porch with shed-roof extension, and faces the alley. The house has a square plan and poured concrete foundation. It has horizontal wood siding and exposed rafters. It has a side-gable roof of moderate pitch, and is finished in composition shingles. The windows are two-light sliding sash, vertically divided, with plain trim. The northernmost portion of the building appears to be a later addition. In addition, there appears to be a smaller shed-roof addition to the south side of the house, and at least two windows have been enclosed. At least three additions appear to have been made to the house.

814 ½ Orchard Street; taken from alley between Orchard and Beaver Streets, view to northwest.
